New Vanguard

# German Battleships 1939–45

Gordon Williamson • Illustrated by Ian Palmer

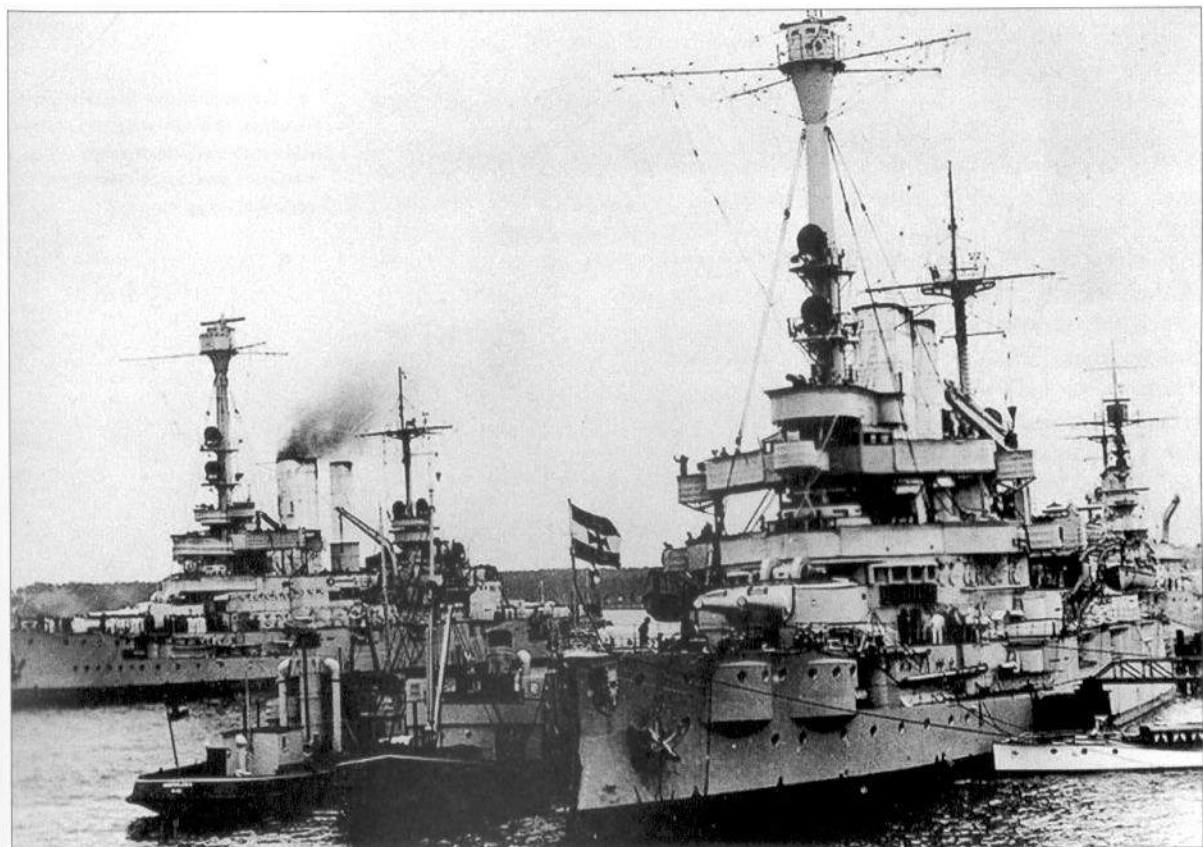
The two dreadnoughts *Schlesien* (left) and *Schleswig-Holstein* (right) in their post-refit form, with the forward funnel removed. This pre-1935 photograph shows the old flag of the Reichsmarine being flown on the bow flagstaff.

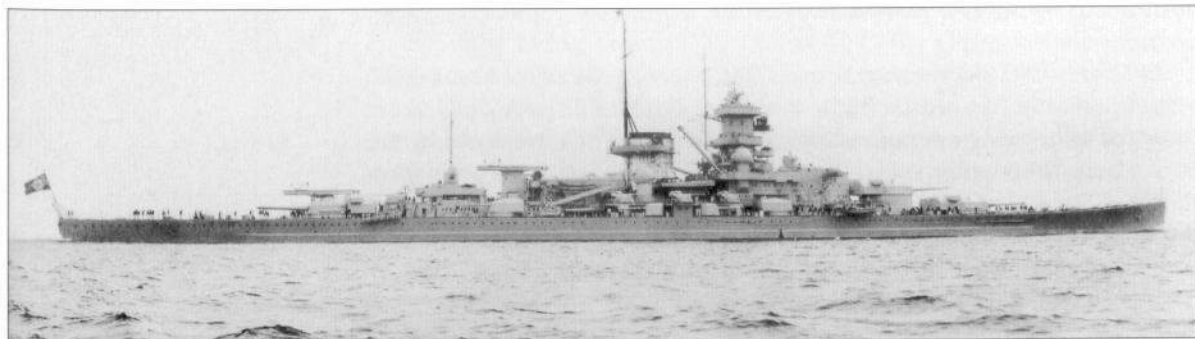
An excellent broadside study of *Scharnhorst* as originally completed. At this point she was almost identical to *Gneisenau*.

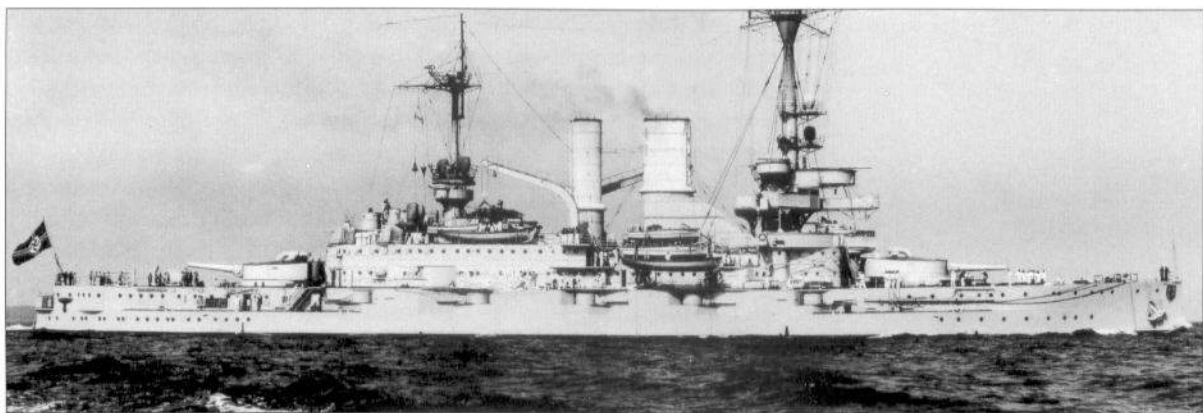
*Schleswig-Holstein* after her refit. Note the new *Reichskriegsflagge* being flown in this post-1935 photograph. Note also the large bronze eagle and swastika mounted on her hullside near the stern.

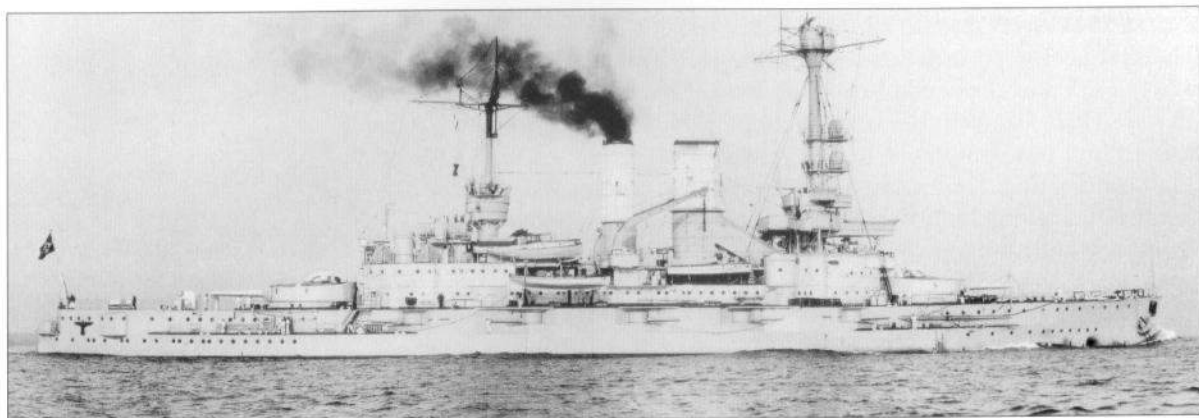
**Schlesien**, post-refit. The two sisters were virtually identical by this point.

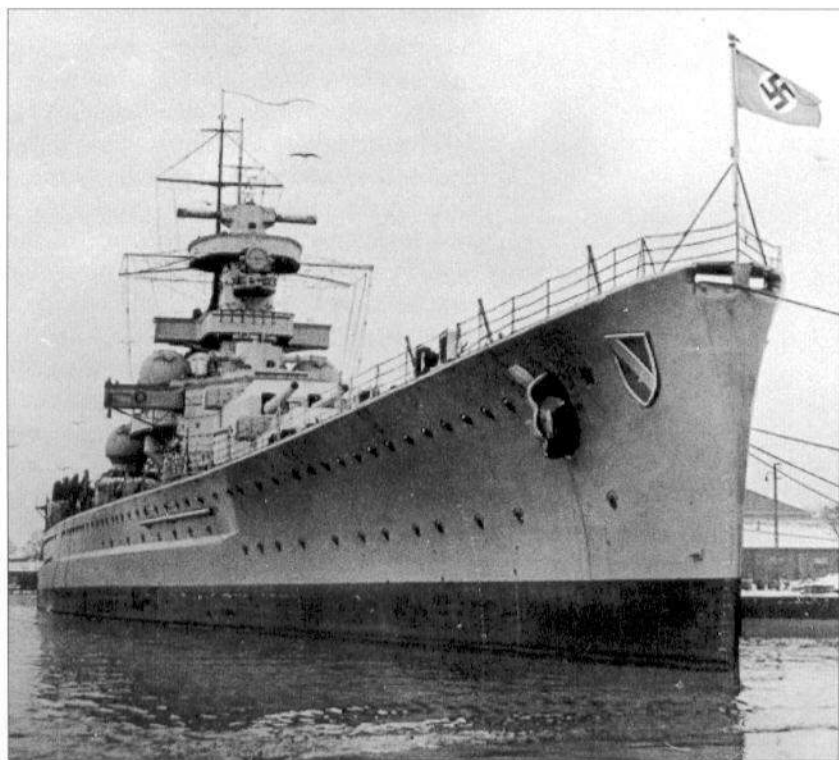
**A bow view of the *Scharnhorst* in her initial form with straight stem. The 'mattress' radar antenna for the FuMO system has not yet been fitted to the rangefinder on her foretop. During her refit, the anchors were also moved from the hullside ports to cluses on the edge of the deck.**

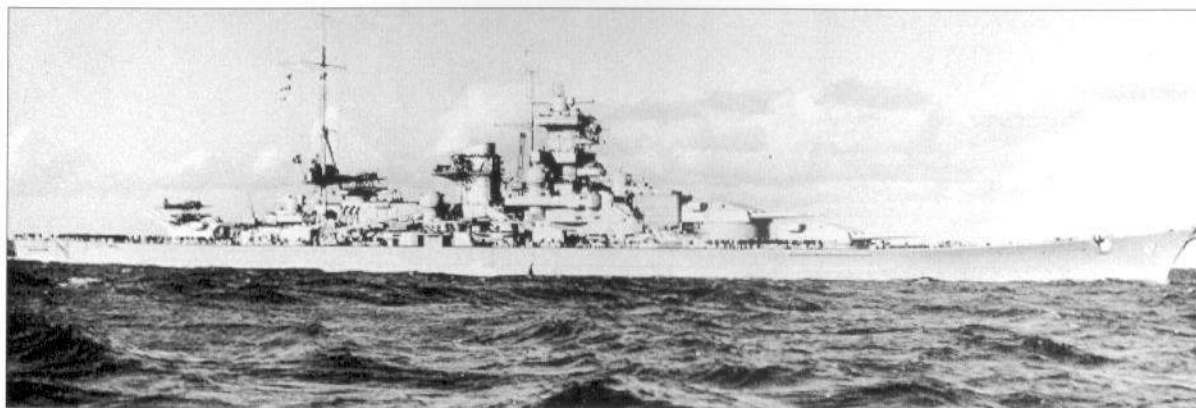
**Scharnhorst in post-refit form with 'Atlantic' bow and angled funnel cap, but still retaining the second aircraft catapult on turret 'Caesar'. Although very similar to Gneisenau, her identity is immediately established by the siting of the mainmast, which on Gneisenau remained sited to the rear of the funnel.**

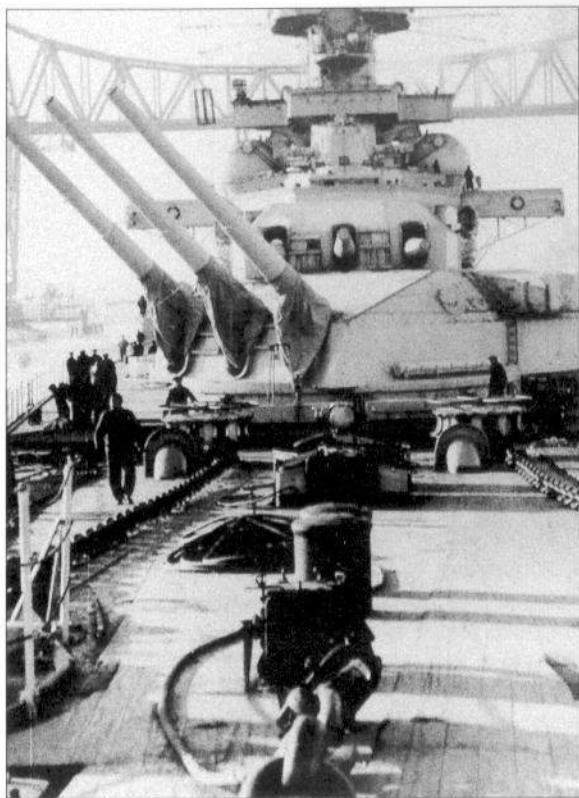
The view towards the forward turrets 'Anton' and 'Bruno' from the bow of *Scharnhorst*, gives a good impression of the huge size of her main armament. Note that the canvas blast bags are fitted on the gun barrels of turret 'Anton' only. This shot also gives a good view of the large searchlight mounted on the face of her tower just above the bridge.

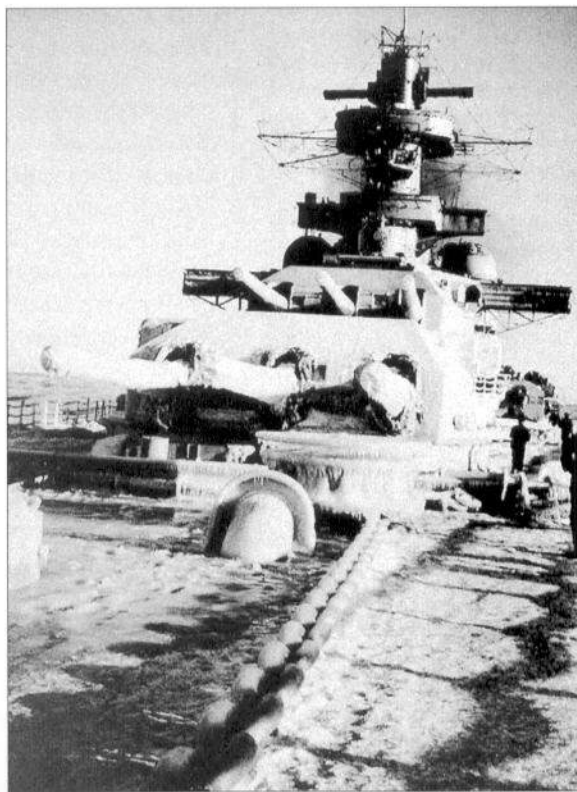
**A further view from the bow of *Scharnhorst* shows just how heavily iced this area became during severe winter weather, a problem exacerbated by her tendency to ship vast amounts of water over the fo'c'sle in heavy seas.**

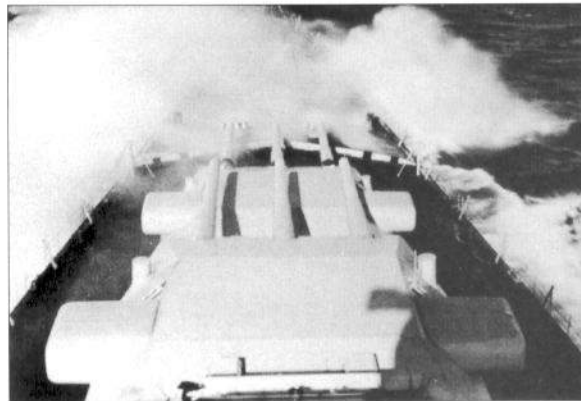
A view down towards the bow from *Scharnhorst's* bridge area gives a good impression of just how 'wet' a ship she was. The constant flooding of waves over her fo'c'sle caused regular problems with the electrics of her forward turrets.

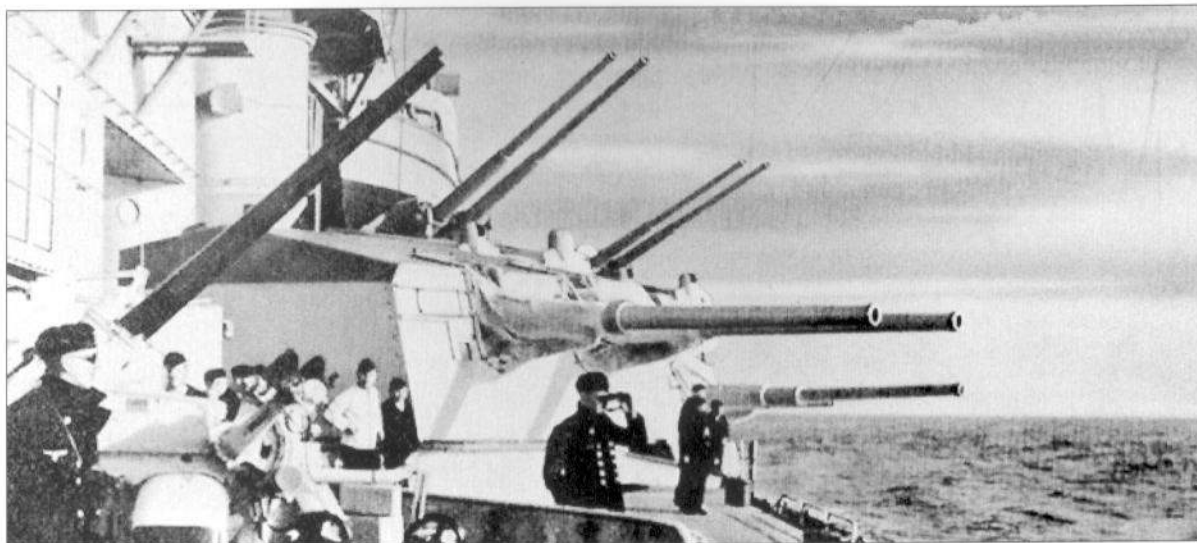
An excellent view of one of *Scharnhorst's* secondary turrets, mounting 15cm guns. The guns shown at high elevation behind this turret are those of her main 10.5cm flak batteries. One of the ship's boats can be seen just above these flak guns.

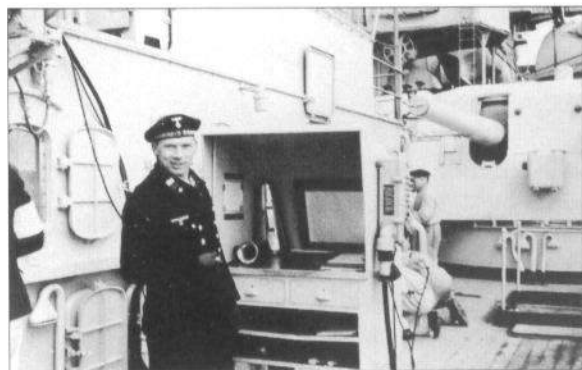
Another detail view taken on *Scharnhorst's* starboard side main deck looking forward towards one of her secondary armament turrets.

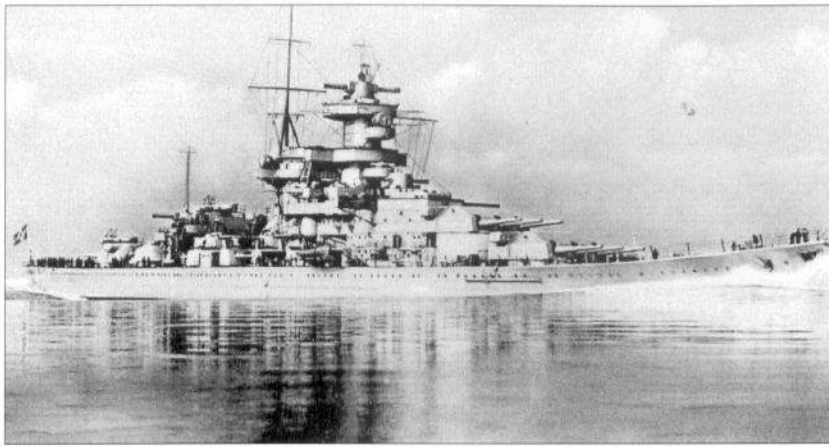
*Gneisenau* is seen here in her initial form, with straight stem and with the catapult still fitted over turret 'Caesar'. Given the flat calm seas and the sizeable bow wave (compared to the previous photograph), it seems likely that this shows her at high speed during her trials.

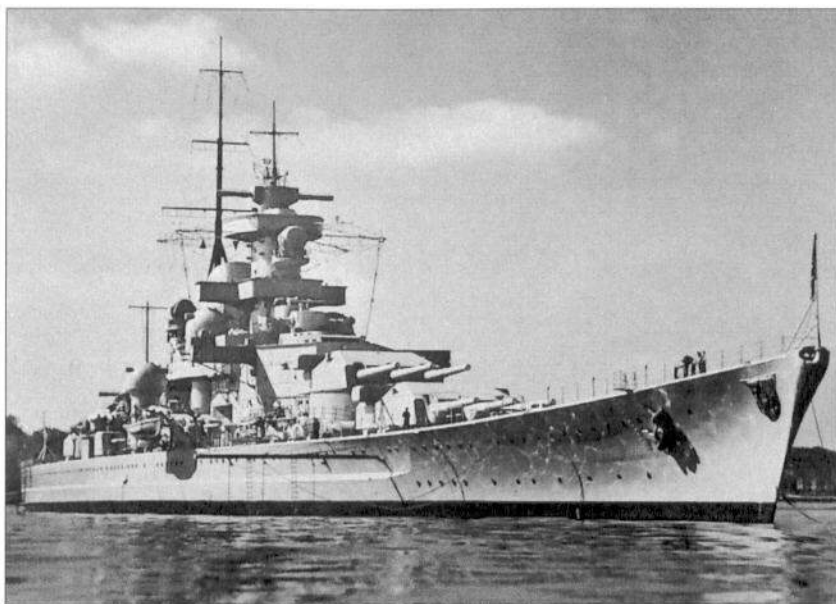
This view shows *Gneisenau* after her refit, now sporting the raked 'Atlantic' bow, which did little to cure her tendency to ship considerable amounts of water over her fo'c'sle at speed or in heavy seas. The angled funnel cap can just be seen by the base of her mainmast. That this is a pre-war photograph is confirmed by the presence of the ship's crest on the bow. It was removed on the outbreak of war.

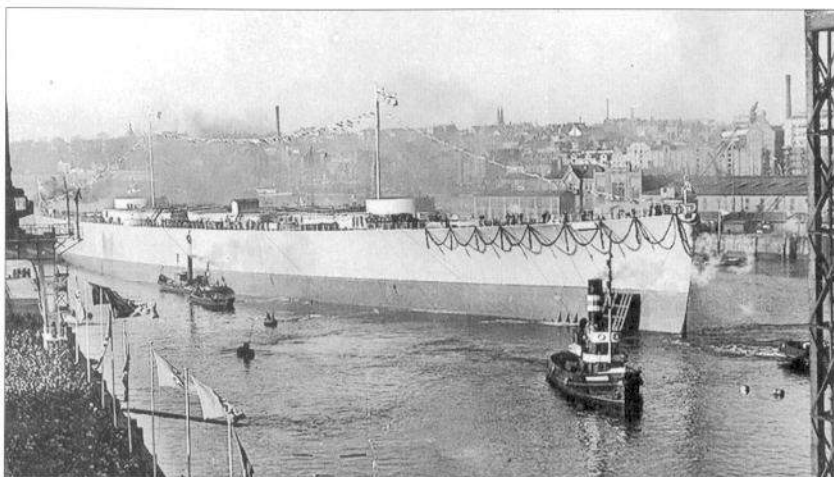
*Bismarck's* hull slides onto the waters at the Blohm & Voss yard in Hamburg on 14 February 1939. She has the original straight stem that was replaced by an 'Atlantic' bow during her fitting out. Only the first level of superstructure has been completed along with the raised barbettes for turrets 'Bruno' and 'Caesar'.

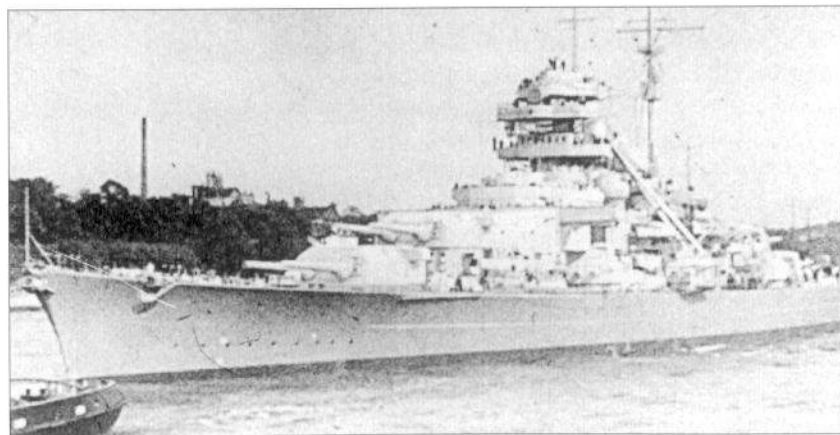
**The *Bismarck* shortly after her completion and commissioning, immaculate in her fresh light grey paintwork. Note that the main fire control rangefinder on her foretop has not yet been fitted.**

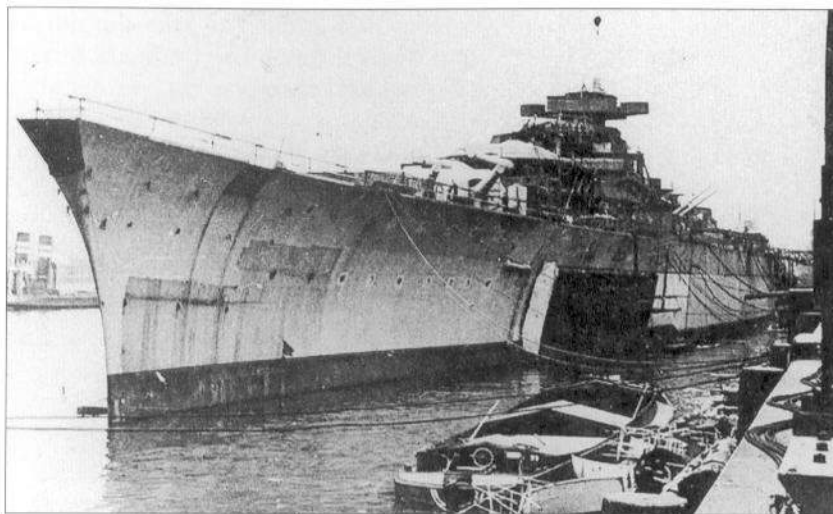
***Bismarck* during fitting out. The straight stem originally fitted has already been replaced by the 'Atlantic' bow.**

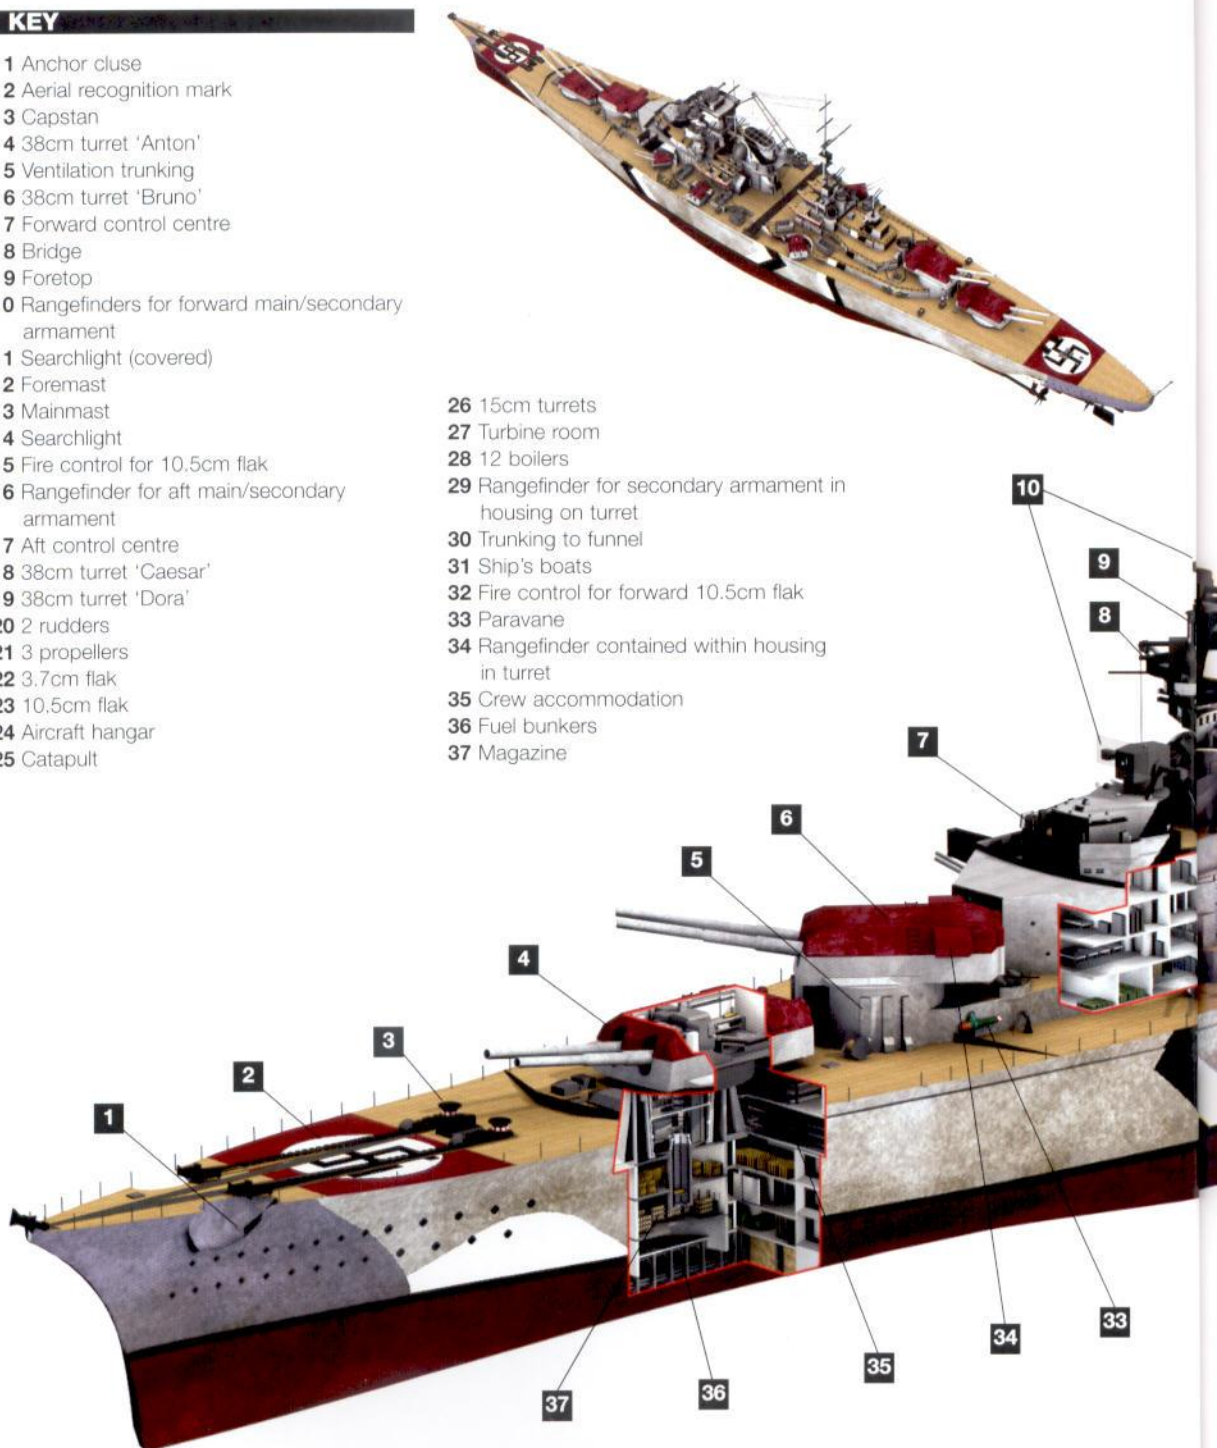
# D: CUTAWAY VIEW - BISMARCK-CLASS BATTLESHIP

- 1 Anchor cluse
- 2 Aerial recognition mark
- 3 Capstan
- 4 38cm turret 'Anton'
- 5 Ventilation trunking
- 6 38cm turret 'Bruno'
- 7 Forward control centre
- 8 Bridge
- 9 Foretop
- 10 Rangefinders for forward main/secondary armament
- 11 Searchlight (covered)
- 12 Foremast
- 13 Mainmast
- 14 Searchlight
- 15 Fire control for 10.5cm flak
- 16 Rangefinder for aft main/secondary armament
- 17 Aft control centre
- 18 38cm turret 'Caesar'
- 19 38cm turret 'Dora'
- 20 2 rudders
- 21 3 propellers
- 22 3.7cm flak
- 23 10.5cm flak
- 24 Aircraft hangar
- 25 Catapult
- 26 15cm turrets
- 27 Turbine room
- 28 12 boilers
- 29 Rangefinder for secondary armament in housing on turret
- 30 Trunking to funnel
- 31 Ship's boats
- 32 Fire control for forward 10.5cm flak
- 33 Paravane
- 34 Rangefinder contained within housing in turret
- 35 Crew accommodation
- 36 Fuel bunkers
- 37 Magazine

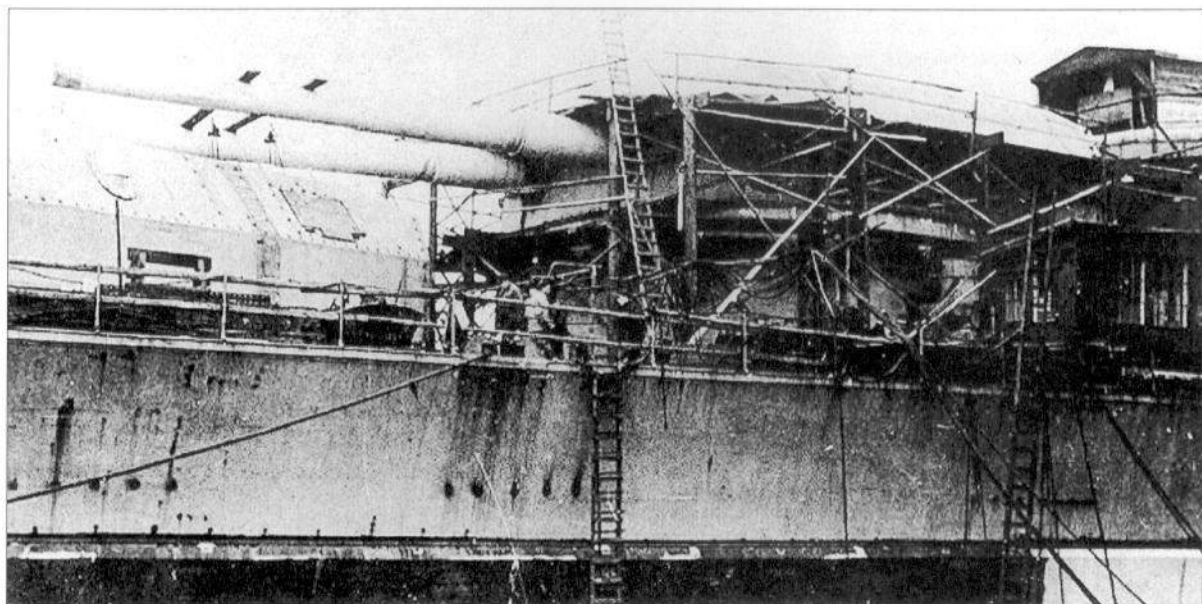
Construction of the main 38cm gun turret 'Bruno' during fitting out. The guns are in place and work is ongoing in building the armoured turret around them. The plethora of scaffolding and ladders is typical of a ship under construction.

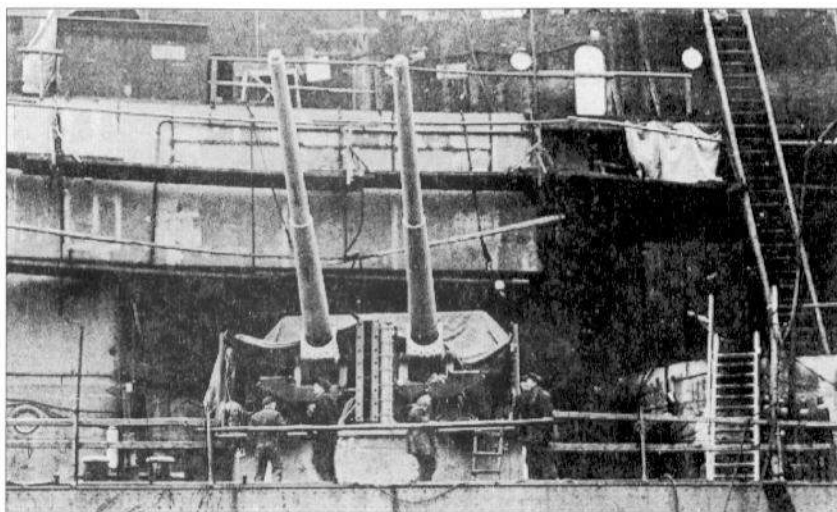
Construction of one of *Bismarck's* 10.5cm twin heavy flak guns. Note how the barrels are first installed on the base mount, and then the turret housing built around them.

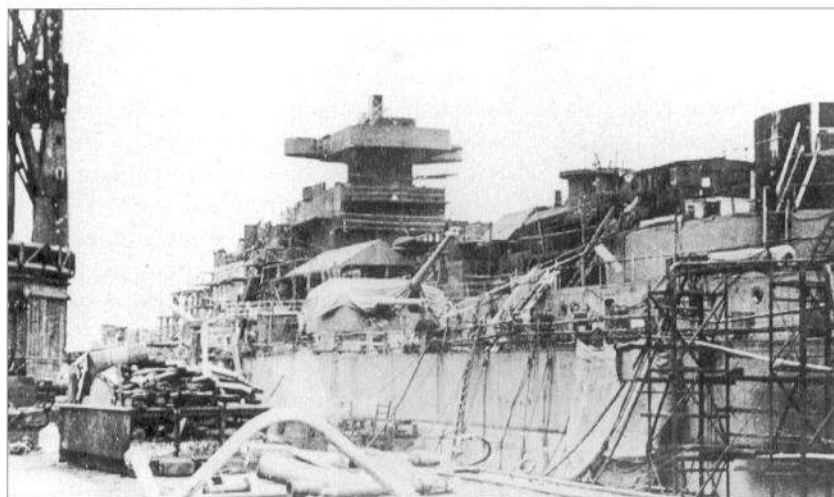
Bearing little resemblance to the sleek, graceful ship she would soon become, *Bismarck* is covered with clutter and liberally draped with electrical cabling to power the workers' tools and provide lighting to the ship's interior. The roofed structure just visible above the secondary turret is the port hangar for the ship's Arado 196 floatplanes.

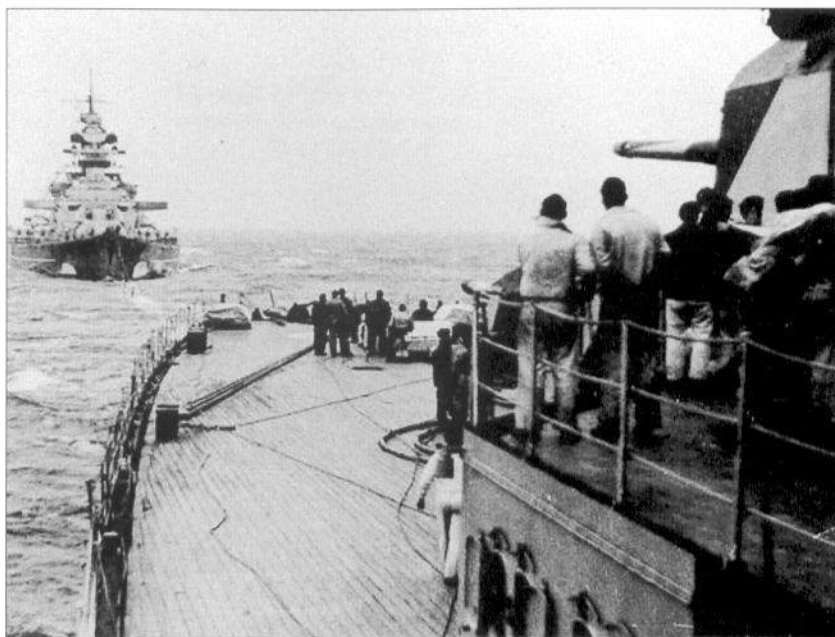
*Bismarck* carrying out refuelling from *Prinz Eugen* during training exercises. The massive beam of this huge warship can be seen to good effect here. The dark grey forward part of the hull and false bow waves can also be seen clearly.

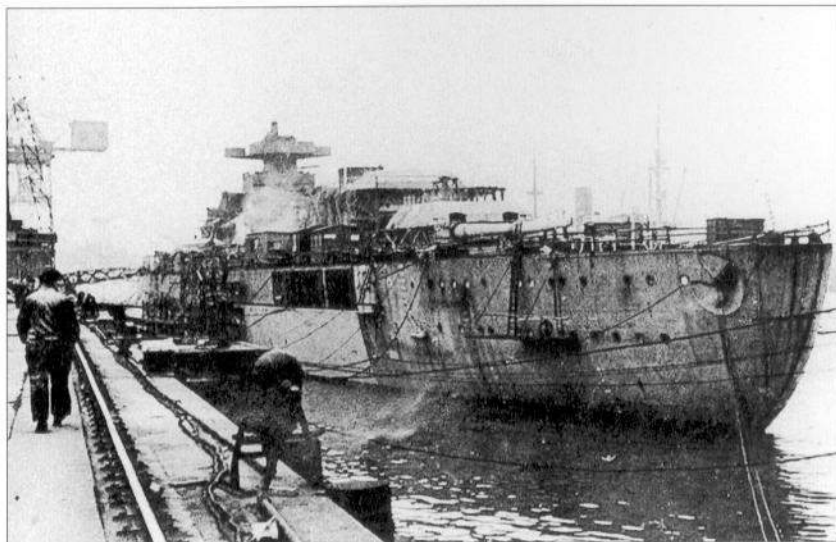
The massive turret 'Dora' can be seen in this stern view of *Bismarck* during her fitting out.

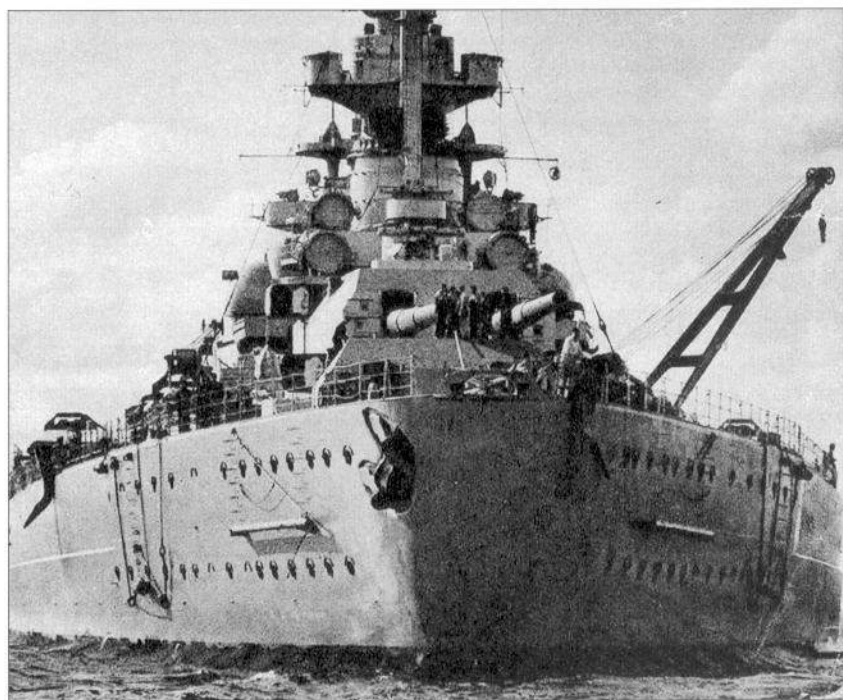
LEFT The sheer bulk of *Bismarck* is clear from this stern view. The size of the turrets can be gauged by the crew figures standing on the roof of turret 'Dora'. The large derrick seen to starboard is used for recovering the ship's boats and the Arado floatplanes.
