# M8 Greyhound Light Armored Car 1941–91

Steven J Zaloga • Illustrated by Tony Bryan

# M8 GREYHOUND LIGHT ARMORED CAR 1941-91

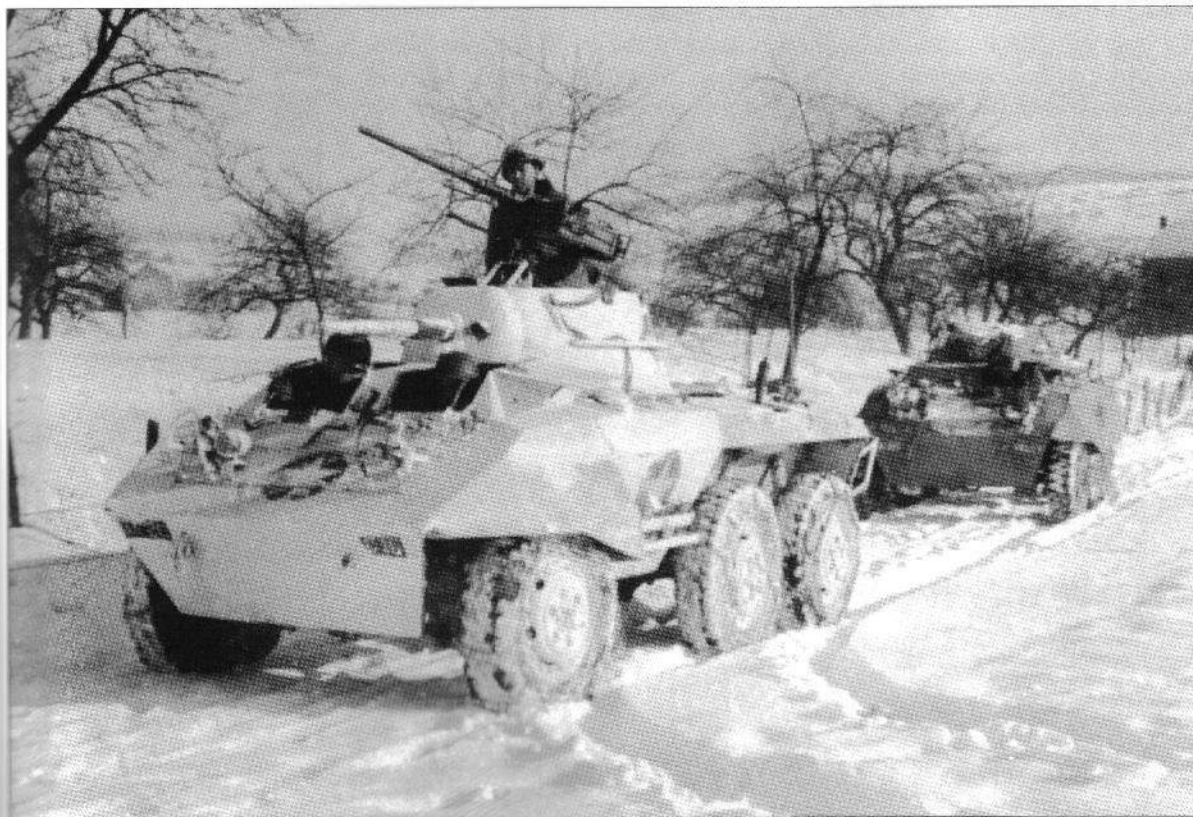
**This patrol of M8 armored cars from C Troop, 2nd CRSM, 2nd Cavalry Group was part of the spearhead of Patton's Third Army during operations in the Ardennes in January 1945. The lead vehicle has had a thorough winter whitewash. The high ground pressure of the M8 limited its mobility in deep snow. (NARA)**

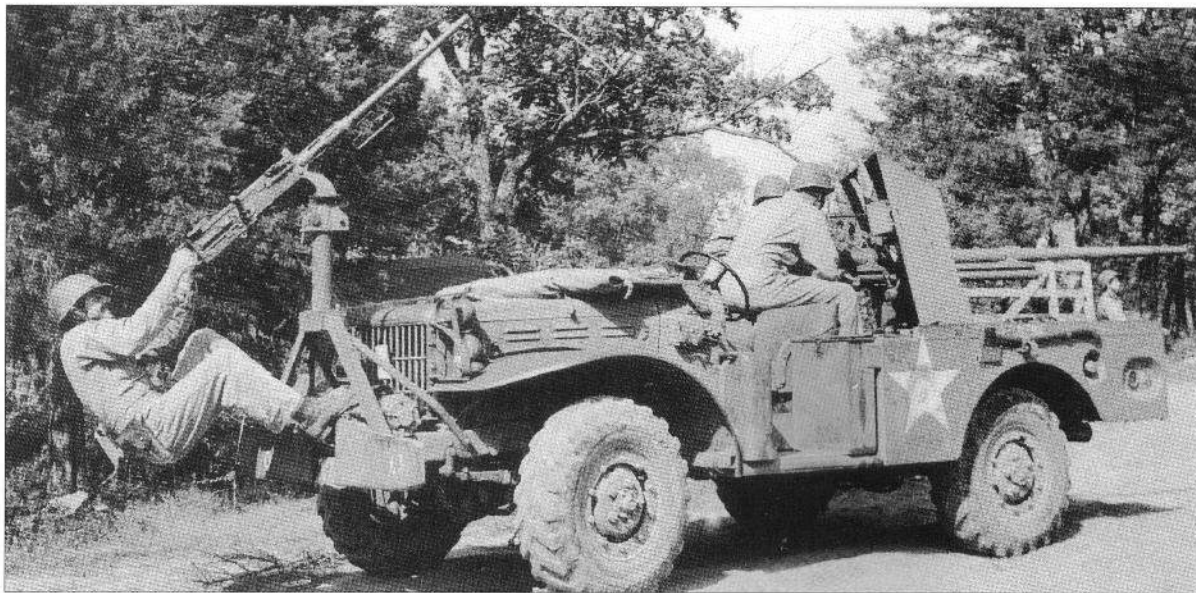
The T22 and T23 37mm gun motor carriages were originally designed to replace the expedient M6 37mm GMC in tank destroyer battalions. This was simply a  $\frac{3}{4}$  ton truck with a 37mm gun mounted in the rear bed and one is seen here during training exercises in the United States in 1942. In view of the limited performance of the 37mm gun, the vehicles were reclassified as light armored cars. (NARA)

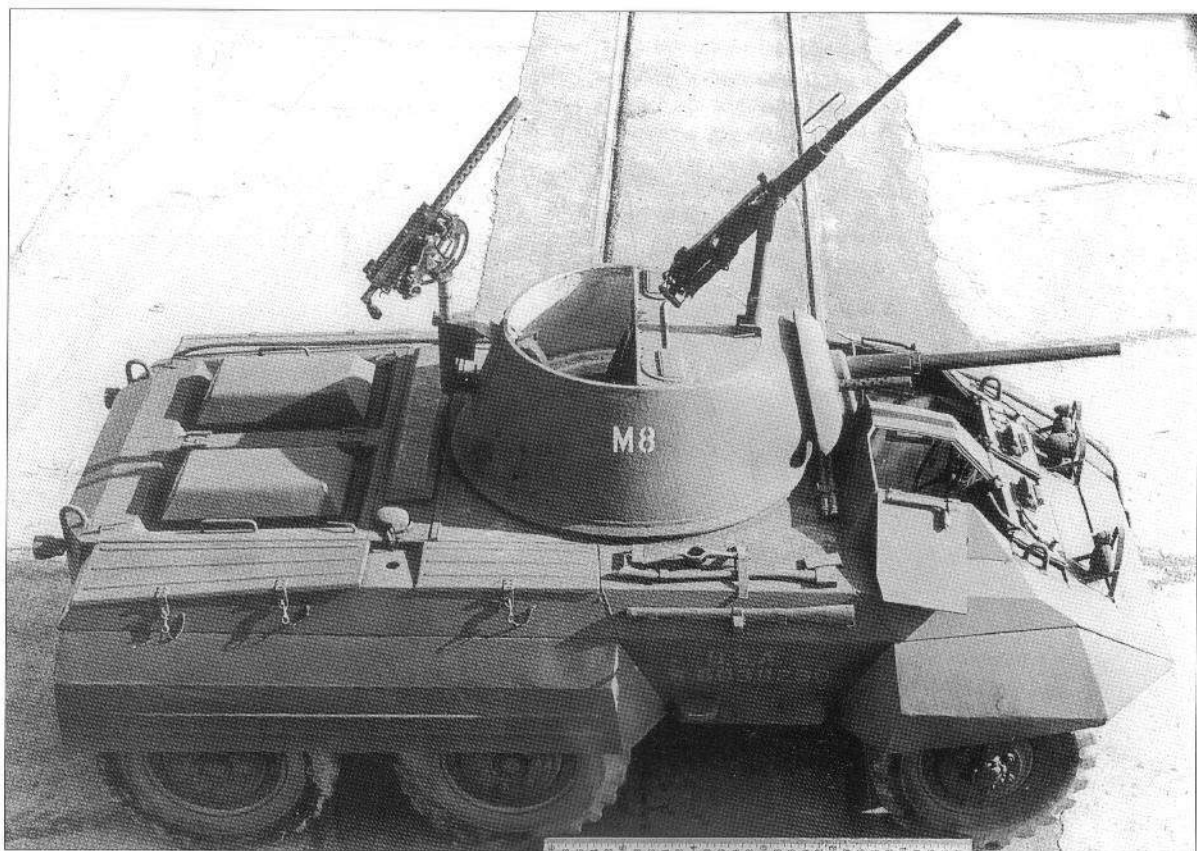
**The first production M8 armored car, serial number 6, was completed at the Ford St. Paul plant in March 1943. Like the T22E2 pilot, it used a cast turret with periscopes for the gunner and commander. The anti-aircraft machine gun arrangement had still not been settled at this time. (NARA)**

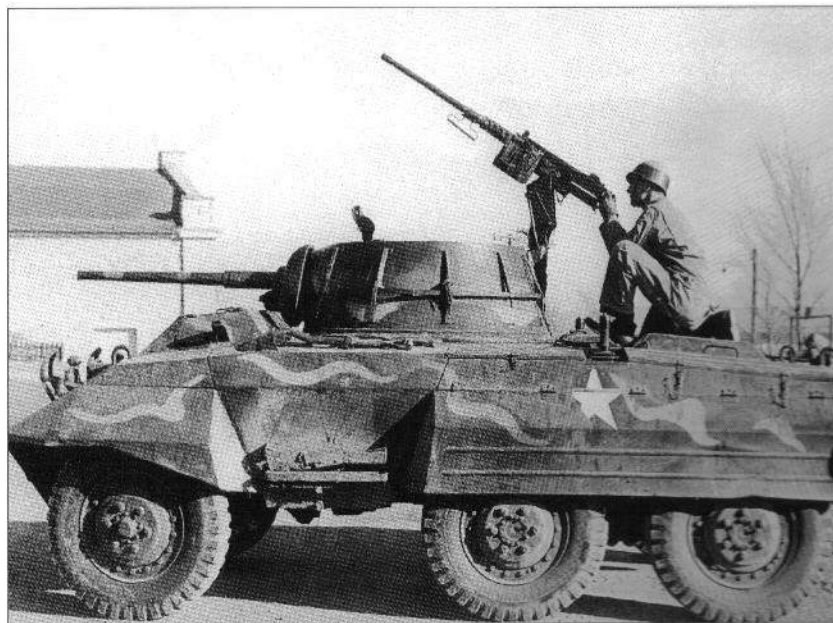
The cavalry pressed for an antiaircraft machine gun for the M8 leading to the development of the D67511 folding pintle bracket mount seen here during trials. Adopted for production because it was lighter than a ring mount, this photo clearly illustrates its main tactical drawback: if the machine gun was aimed at targets in front of the vehicle, the gunner was completely exposed on the rear deck of the vehicle. (NARA)

In late 1943, the long-delayed D67511 folding pintle bracket mount was finally completed and pilots were shipped to Ft. Riley for trials. The Ordnance preferred the new folding mount since it was much lighter than the 650lb ring mount, and the cavalry finally consented. On April 18 1944, Ordnance cancelled the earlier order authorizing the use of the M49C ring mount, and approved instead the D67511 folding mount. Ordnance later examined at least two other machine gun mounts for the M8, but they were not accepted for production. The consequence of this confusion was that none of the vehicles manufactured to date had an antiaircraft machine gun mount.

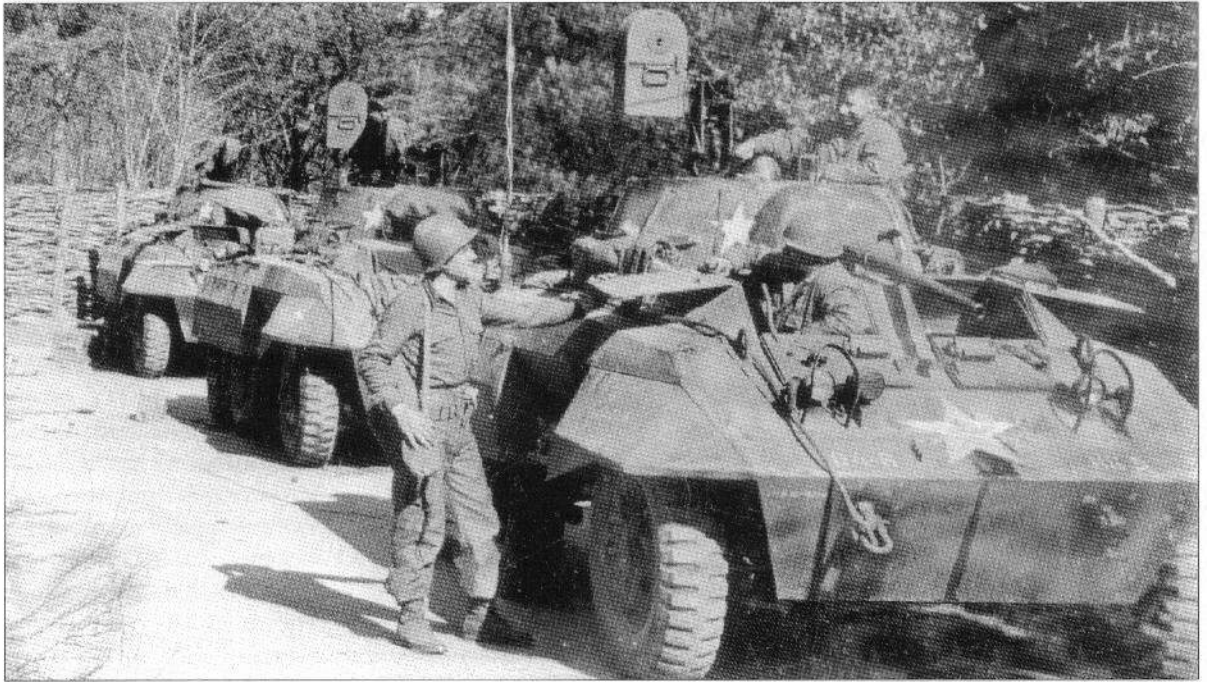
**These M8 armored cars of the headquarters of the 104th CRSM are late production types fitted with the folding pintle mount. This feature entered production so late that it was seldom seen in the ETO. Another curious detail on these vehicles is the use of the large .50-cal. ammunition containers, usually found on anti-aircraft mounts. The lead vehicle has the nickname "Pigeon of Geneva" chalked on the front mud guard, and the unit was photographed at St. Nazaire, France, on March 23 1945. (NARA)**

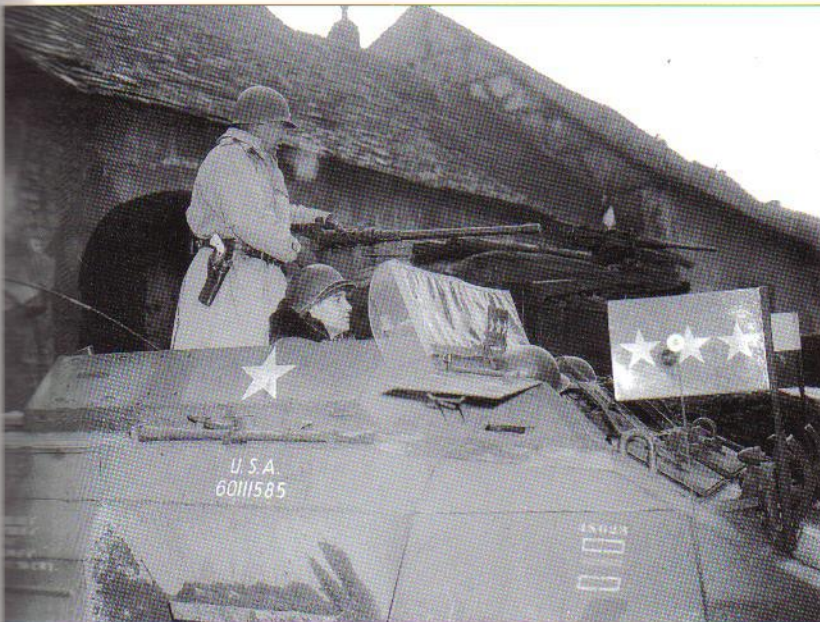
Development proceeded quickly since it was a very simple adaptation of the M8. The vehicle's open parapet was surmounted by a M49 ring mount for a .50-cal. heavy machine gun. The vehicle could carry five to seven men, and if the seats were removed, up to 3,000lb of cargo.

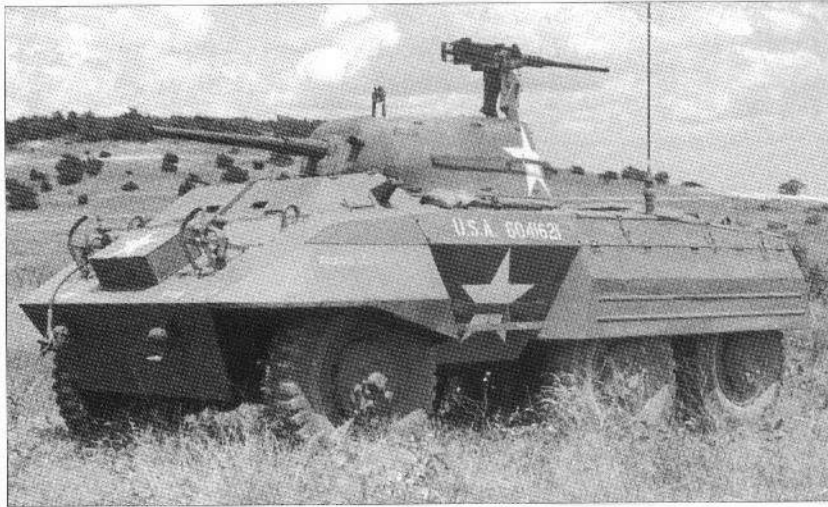
OPPOSITE A close-up of the D67511 folding pintle bracket mount that was accepted for production in April 1944. This is the mount during trials, without the clip added to the forward turret roof on production vehicles to lock the barrel in place during travel. This feature entered production in the spring of 1944, and so was seldom seen on vehicles in combat in the ETO during World War II. (NARA)

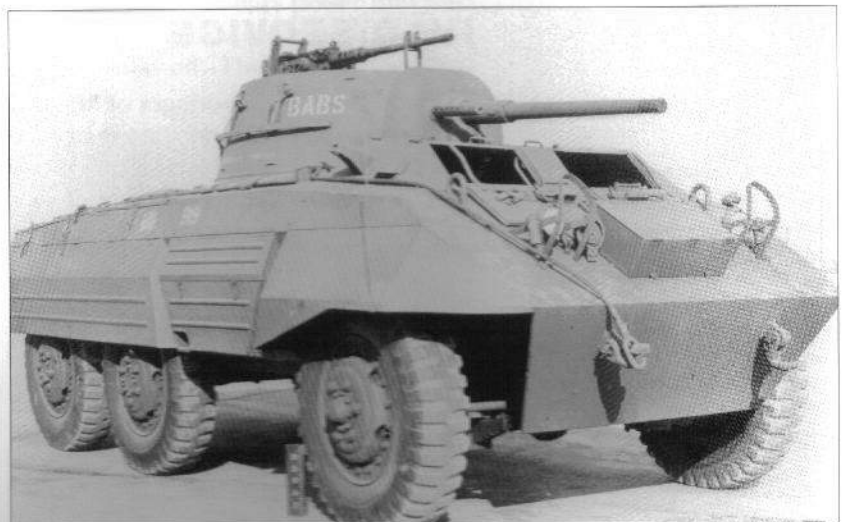
This is an example of the new production configuration in the summer of 1944 with the D67511 folding pintle bracket mount, the barrel clip on the turret roof, and the added stowage box on the glacis plate. This is from the July 1944 production run, and still retains the side mine rack which was dropped from production late in 1944. (Patton Museum)

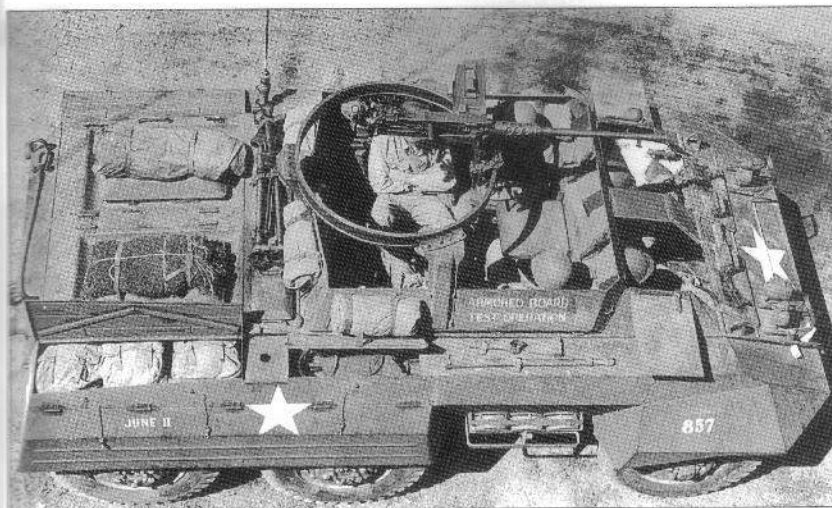
**ABOVE** The M20 armored utility car was a simple adaptation of the M8 armored car with the turret replaced by a simple parapet and ring mount. This photo was taken by the Armored Board at Ft. Knox in 1943 to show the proper positioning of the vehicle stowage. (NARA)

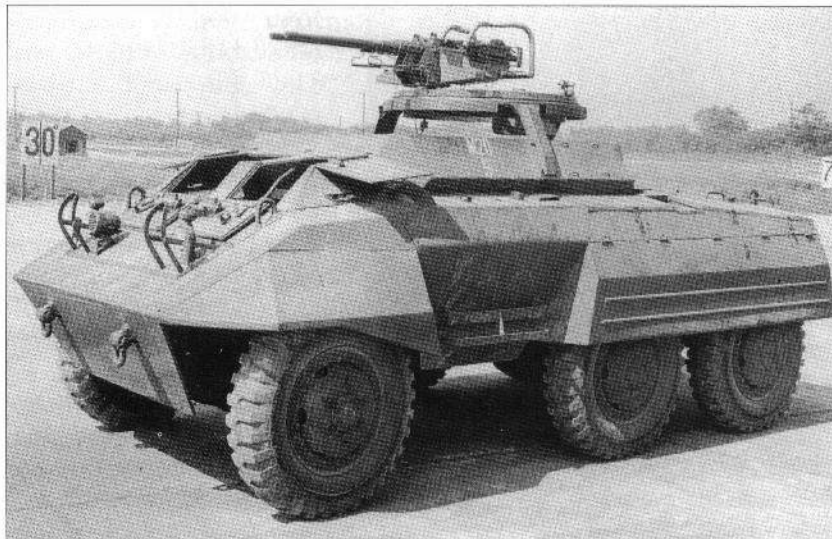
The M20 was used as a test-bed for the T86 machine gun mount, a twin .50-cal. machine gun mount adapted from the Navy's Mk 17. It was never seriously considered for use on either the M8 or M20, but the superior performance of its roller bearing construction led to the improved M66 ring mount. (NARA)

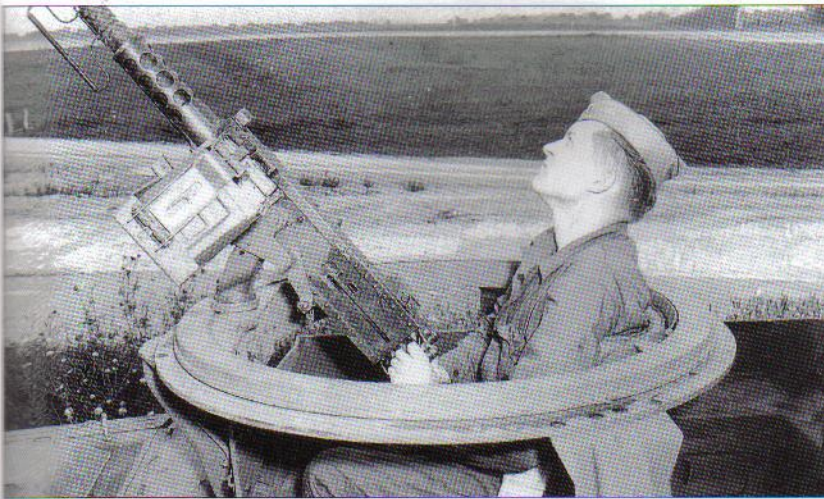
**ABOVE** Following trials of the T86 mount, the Army developed the T107E1 ring mount seen here on an M20. This was deemed superior to the M49 in use as it provided a more steady platform when firing. It was adopted for production on the final series of M20 armored cars as the M66 ring mount. (NARA)

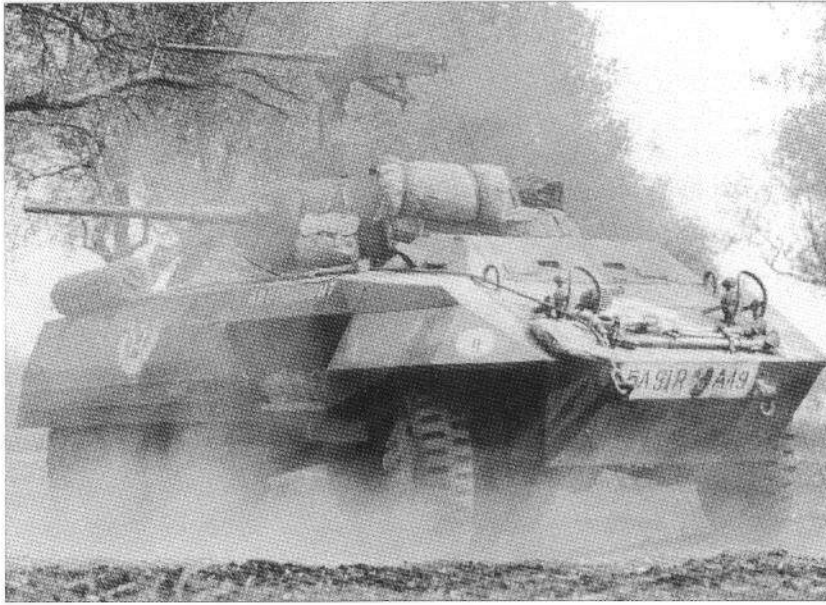
The M8 armored car first went into combat in late January 1944 in Italy with the Fifth Army's 91st Cavalry Reconnaissance Squadron (Mecz), and with the 1st Armored Division's 81st Armored Reconnaissance Battalion. The 91st CRSM saw action on the Cassino front, and this photo shows a vehicle of A Troop near Cassino on February 20 1944. The crews have already started to fit improvised .50-cal. machine gun mounts to the vehicles. (NARA)

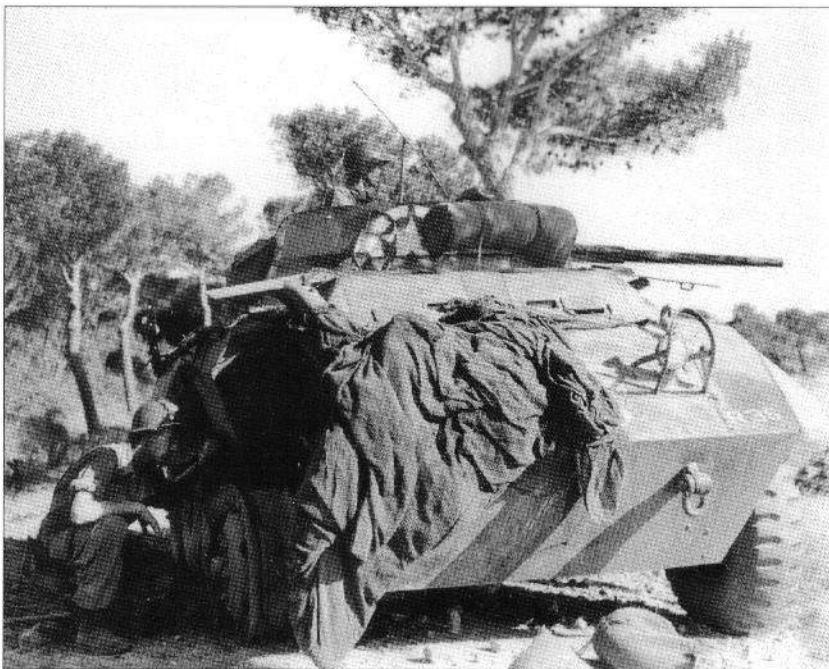
**One of the main problems with the M8 armored car in Italy was its vulnerability to mines. The floor had no armor, which led to high crew casualties when mines were encountered. One of the crewmen of this M8 looks over the damage while the turret crew keeps watch near Castiglione on July 13 1944. This particular vehicle served with a tank destroyer reconnaissance company. (NARA)**

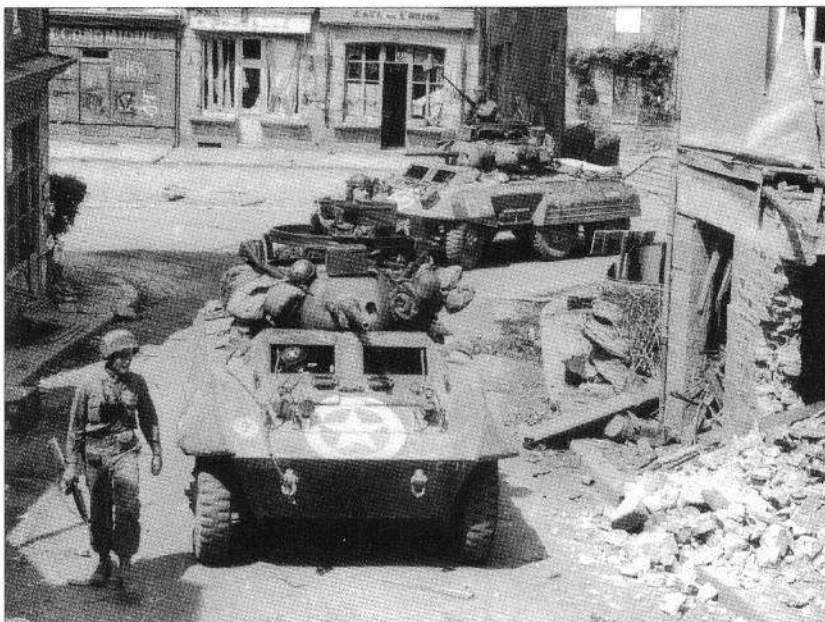
**A pair of M8 armored cars of Company C, 82nd Recon Bn., 2nd Armored Division pass through the road junction at St. Sever Calvados on August 3 1944 during Operation Cobra. They have a machine gun ring field mount so commonly seen in Normandy. This unit welded .50-cal. ammunition boxes to the mount, including one box on top of the gun mantlet. The vehicle to the rear, C-32, is from the July 1943 production run. (NARA)**

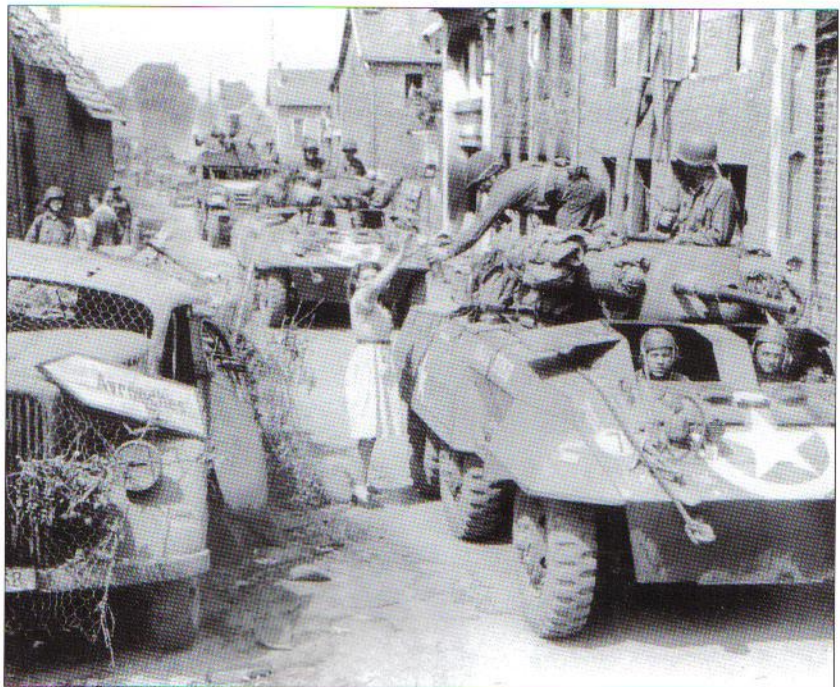
Not all cavalry units adopted the .50-cal. machine gun mount during the Normandy campaign. Here, a patrol from the HQ troop of the 42nd CRSM with the 2nd Cavalry Group receives a warm welcome in Brehal on the northern approaches to Avranches on August 2 1944. Popularly called "Patton's Ghosts", this unit served with the Third Army during the Normandy and Brittany campaigns. This vehicle is from the November 1943 production run. (NARA)

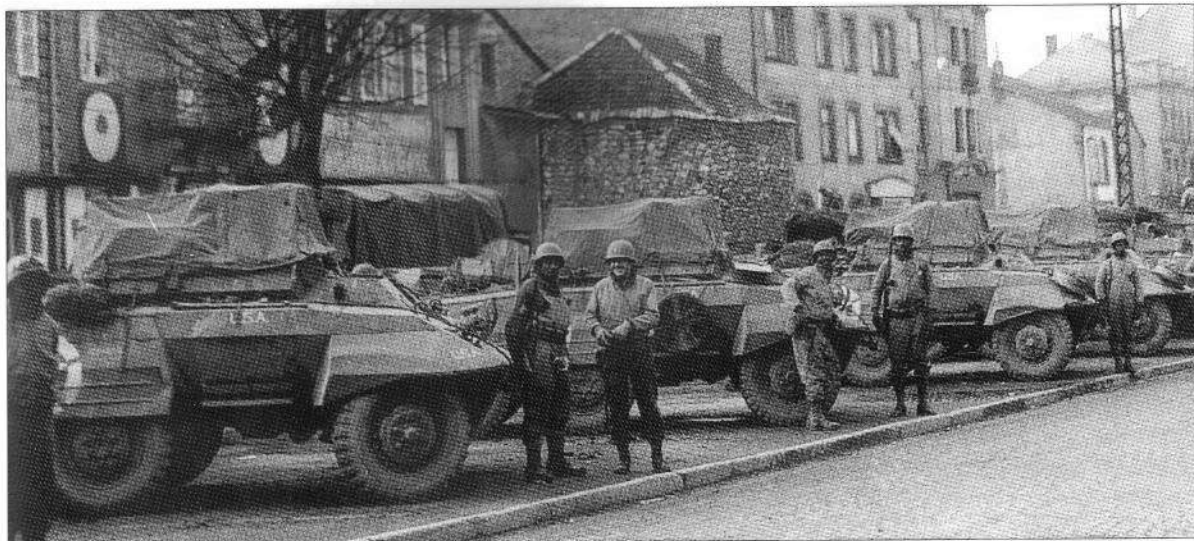
One of the main drawbacks of the M20 as a command car was the cramped conditions in the rear bay and its exposure to the elements. Some units fabricated their own canvas covers to make the M20 more functional in winter conditions. These are a group of M20s of the 827th Tank Destroyer Battalion in Saarbours on December 16 1944. The 827th was one of a number of segregated US armor units that fought in the ETO in 1944–45. (NARA)

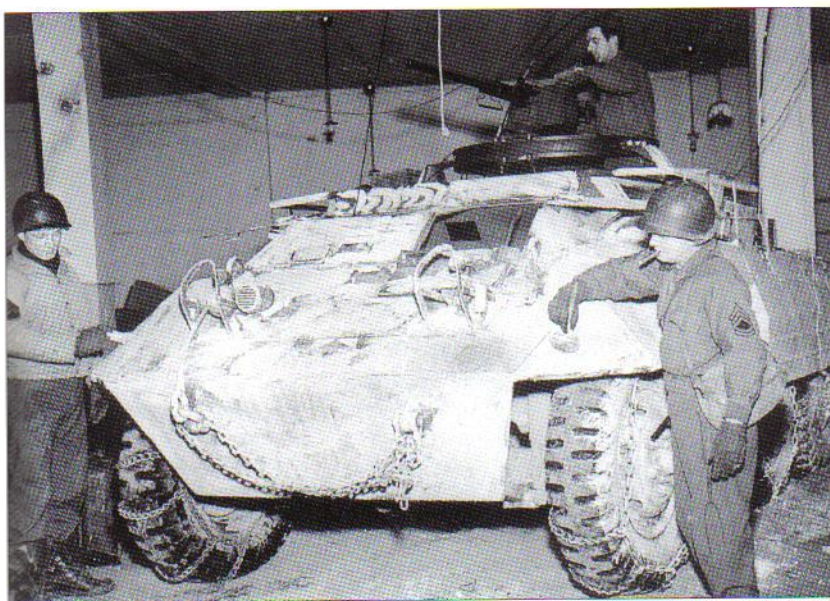
**An M20 armored utility car of the 807th Tank Destroyer Battalion receives a coat of whitewash during a maintenance break in the town of Saalautern on January 13 1945. It has been fitted with snow chains to provide better traction in the winter conditions. (NARA)**

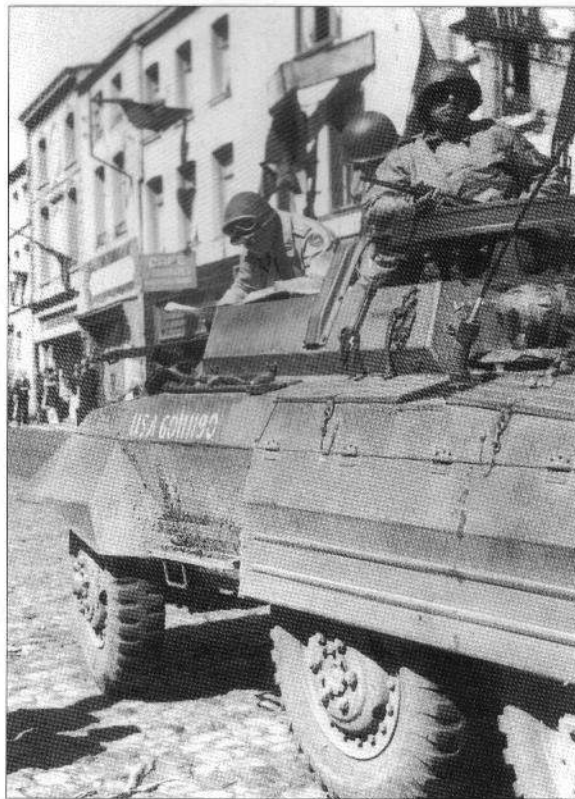
**The M20 armored utility car was widely used by senior commanders in the summer and fall of 1944 before its vices became evident. This is the vehicle of Maj. Gen. "Lightning Joe" Collins, commander of the VII Corps which led the Normandy breakout during Operation Cobra. Here, he is checking his map in the Belgian town of Beaumont on September 4 1944. (NARA)**

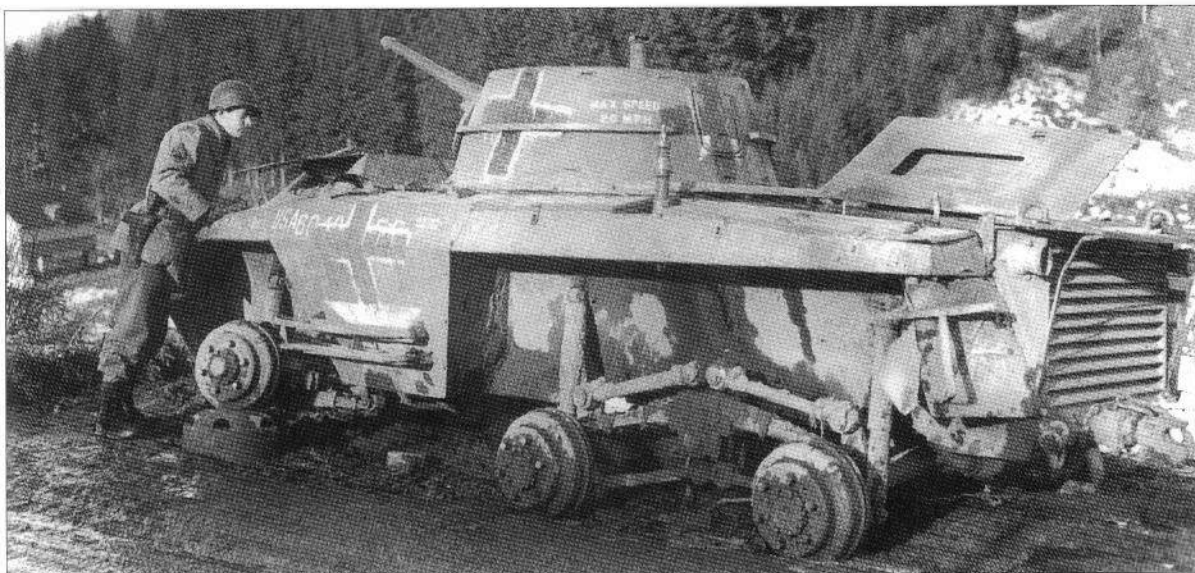
**ABOVE** A number of the 14th Cavalry Group M8 armored cars were abandoned intact, and put back into use by German troops during the fighting around St. Vith during the Battle of the Bulge. This one, named Buffalo Bill, was later knocked out by US artillery. Its stars had been crudely overpainted with German crosses. (NARA)

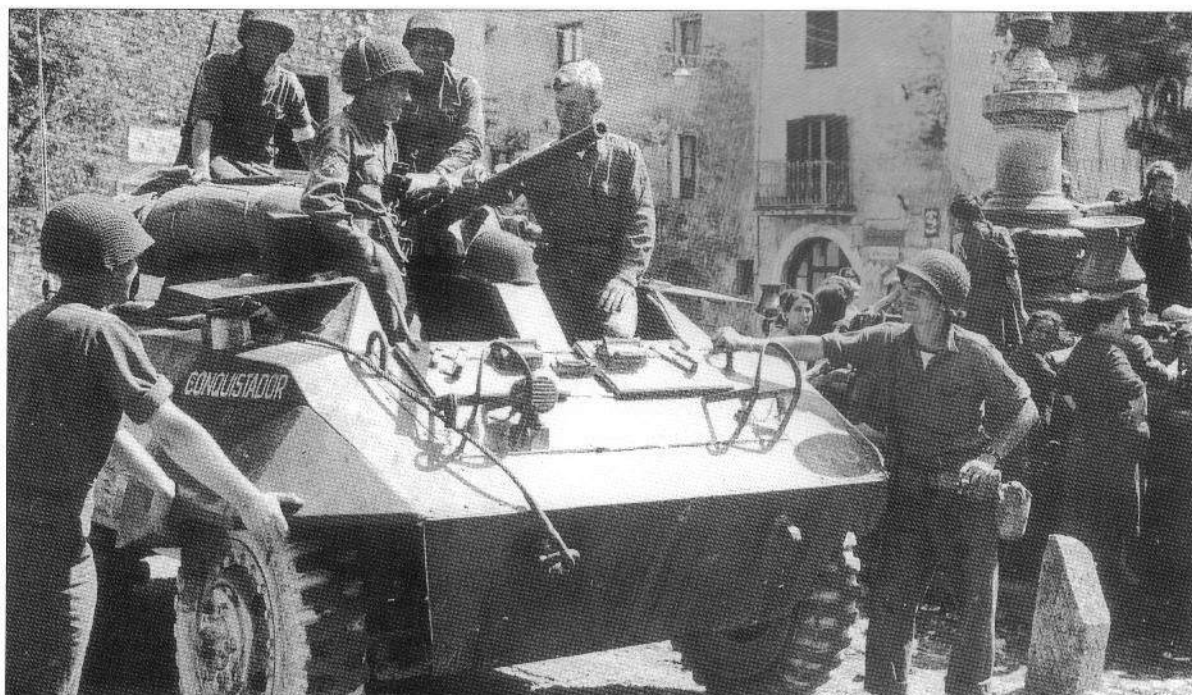
ABOVE The crew of M8 "Conquistador" of Company C, 81st Armored Reconnaissance Battalion, 1st Armored Division, in Norma, Italy, following the breakout from the Anzio beachhead on May 30 1944. This unit was redesignated as the 81st CRSM when the 1st Armored Division adopted the "light" 1943 table of organization in 1944. (NARA)
